CONNECTIONS

Fall 2017 - Issue #1007

PRESERVING A VITAL CONNECTION

M48 Severn Bridge
cable inspection crosses
the finish line ahead of
schedule

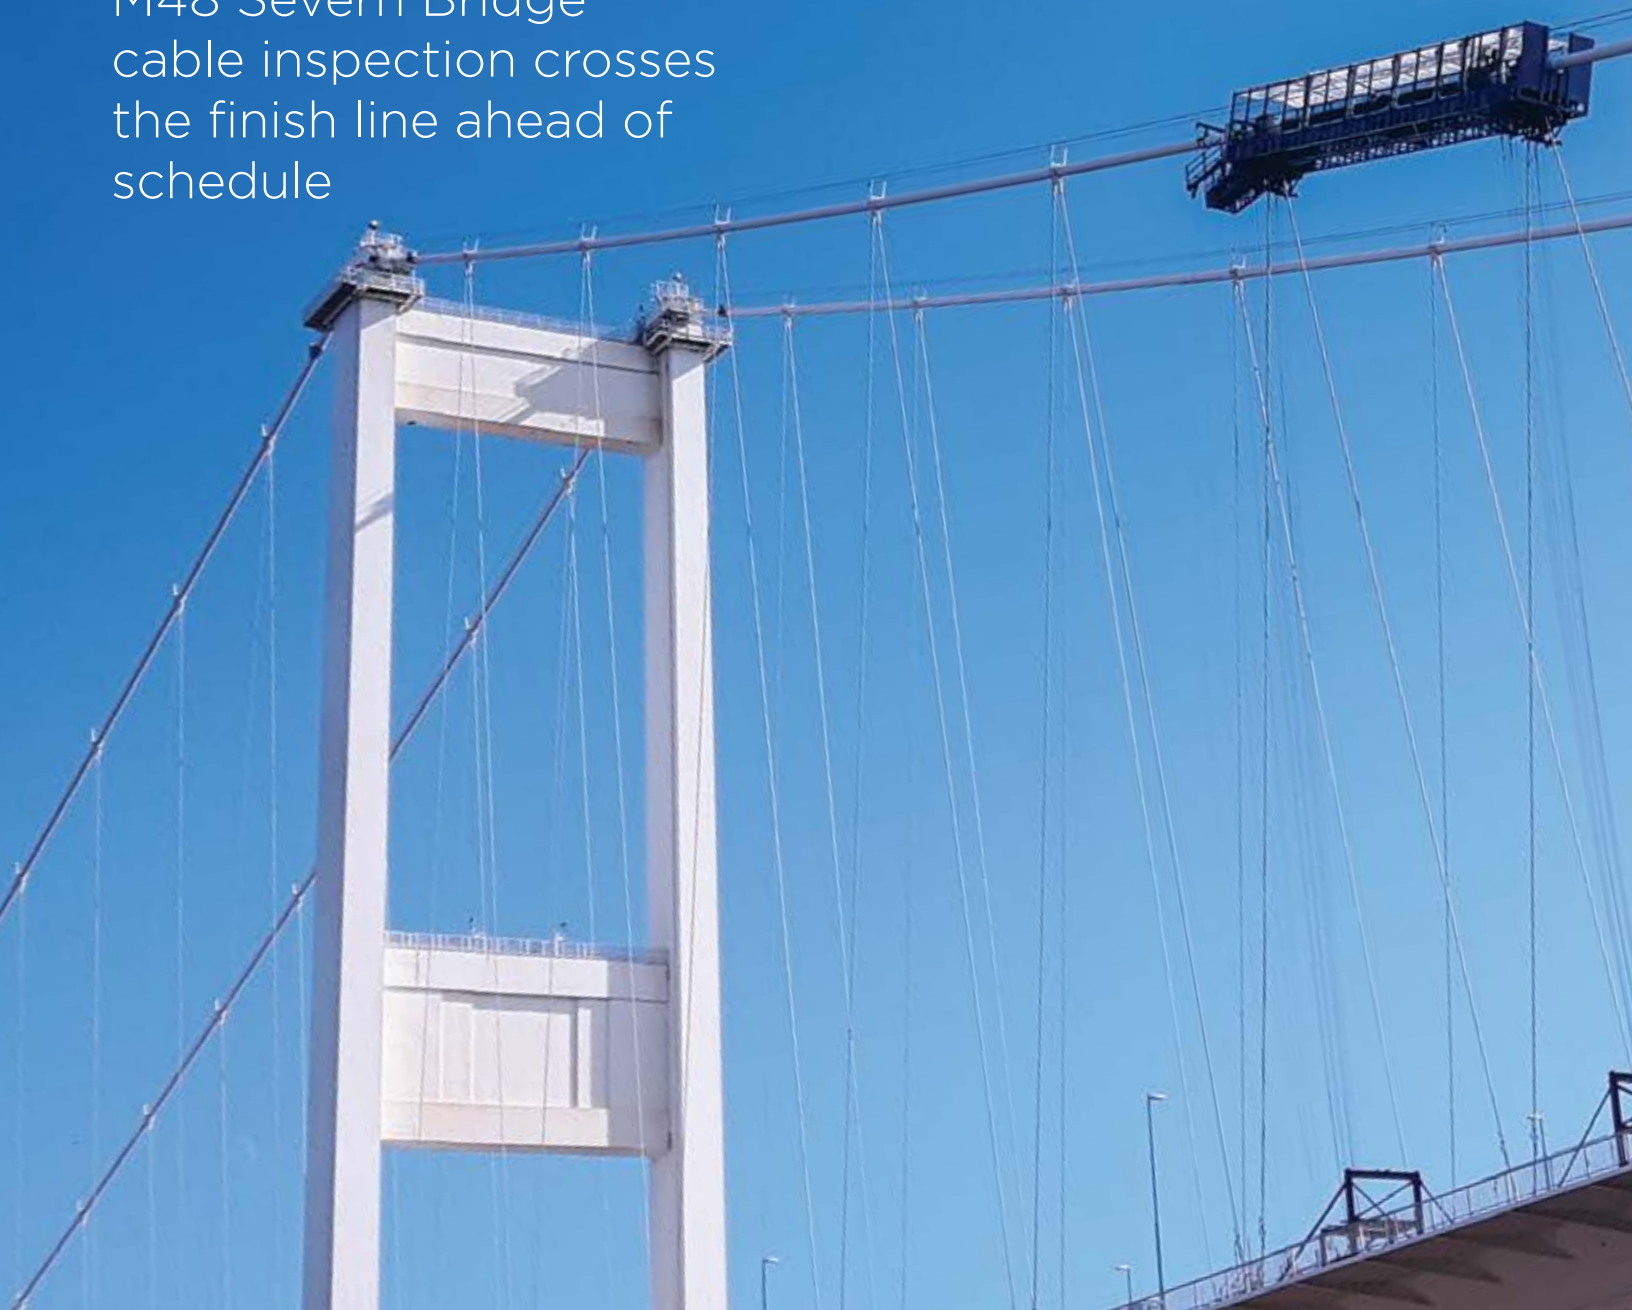
Cover: M48 Severn Bridge with the gantry in its final high level location.

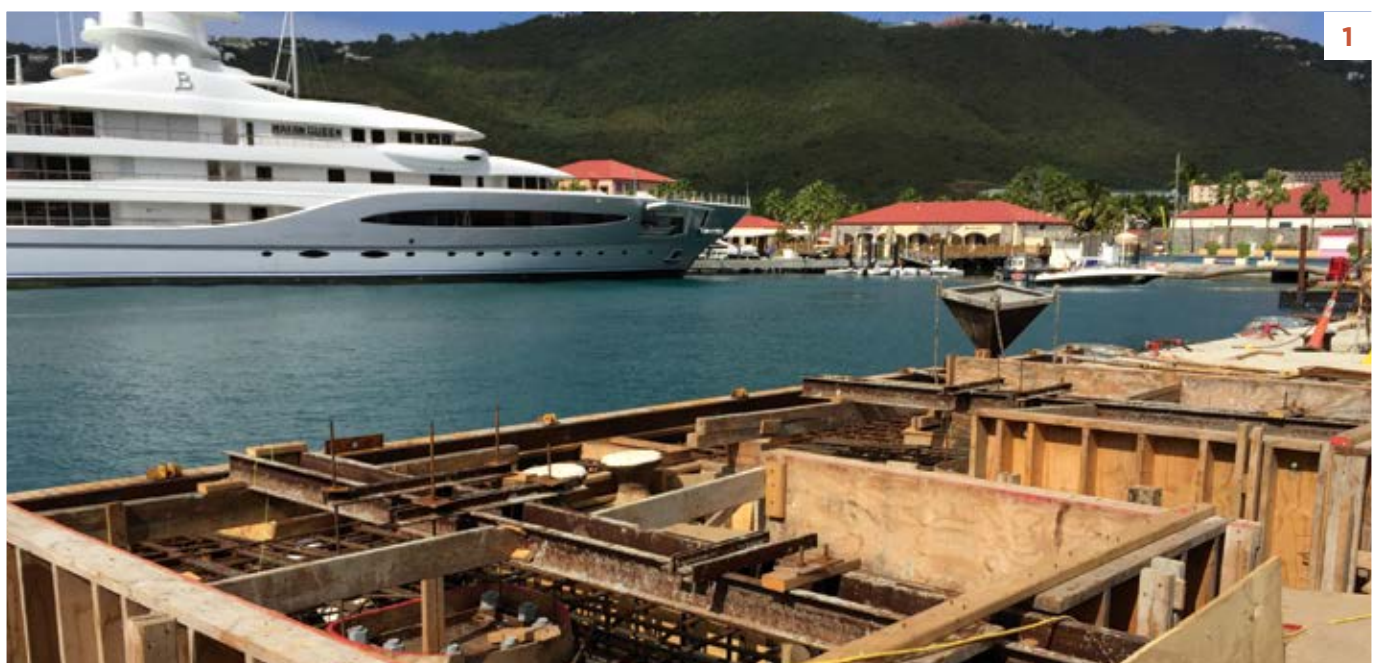
Photo 1: Wood formwork, rebar cages, as well as the EFCO forms and bulkhead rebar in place to support a double bollard and bulkhead concrete pour

Formwork, provided by the company EFCO, was hung from the bulkhead and used to pour bulkhead concrete. AB also hung a total of 38 new fenders on the bulkhead wall to protect the ships from the dock.

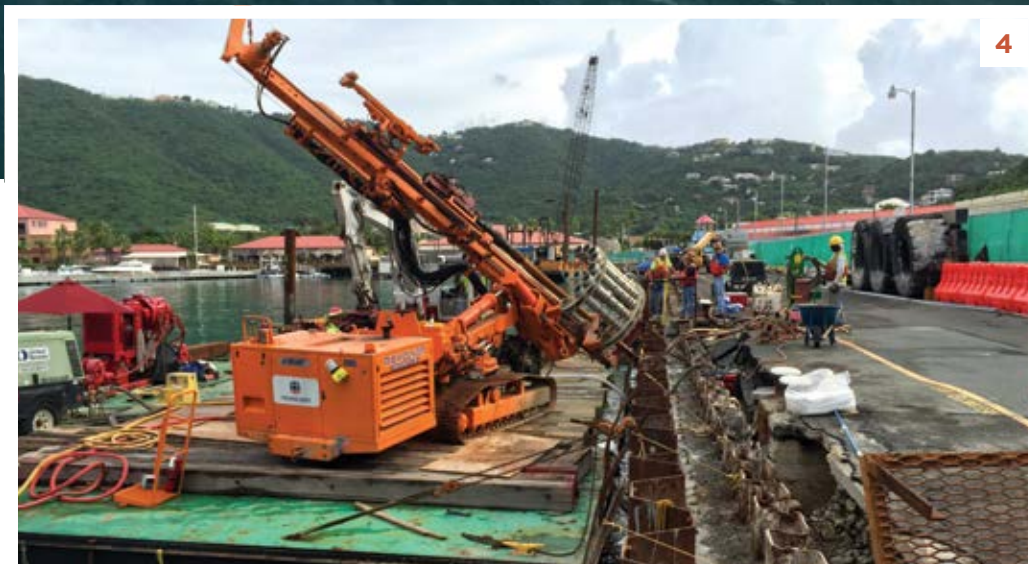
Photo 2: Cruise ship tying off to the newly installed SB-150 Bollards; Photo 3: Cruise ship tying off to the newly installed MT-150 Bollards; Photo 4: Looking east on the WICO dock as AB supports Nicholson (subcontractor) in drilling the holes for the permanent soil anchors

Once the new bulkhead and bollards were placed, they needed to be secured. AB hired Nicholson Construction (Nicholson) as a subcontractor to take on this responsibility. Nicholson used a soil anchor installation rig for drilling anchors and grouting. During this process, several unforeseen obstructions were encountered and even made a redesign necessary at one location, but did not affect schedule.

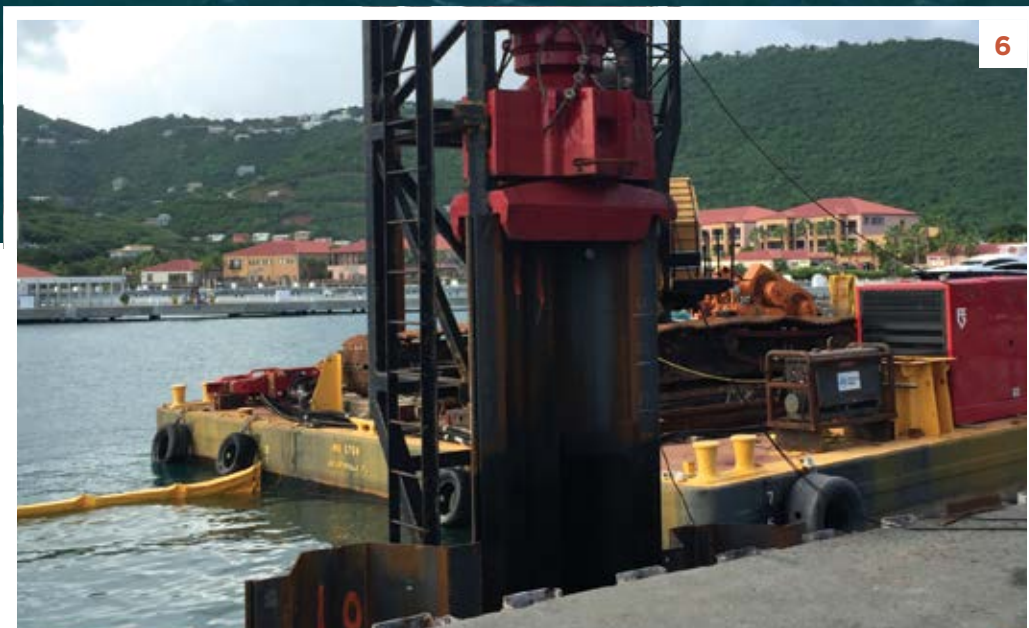
Photo 5: American 9310 moving sheetpile onto the barge; Photo 6: Impact hammer being used to push down a pair of sheet piles

AB was also responsible for driving approximately 700' of sheet pile wall which was prefabricated and delivered to the project site. AB used a barge-based crane (American 9310) to move sheet pile onto the barge and then drive the sheet pile into the ground using an impact hammer. AB encountered a problem when the newly installed sheets at the beginning of the dock widening did not align with the existing sheet piles. After devising a plan with CH2MHILL, AB fixed this issue with a simple closure detail, attaching two pieces of plate steel to the existing sheet pile and the newly driven sheet pile. Then, a grout sock was put in place to fill the gap between each sheet pile wall, providing a barrier.

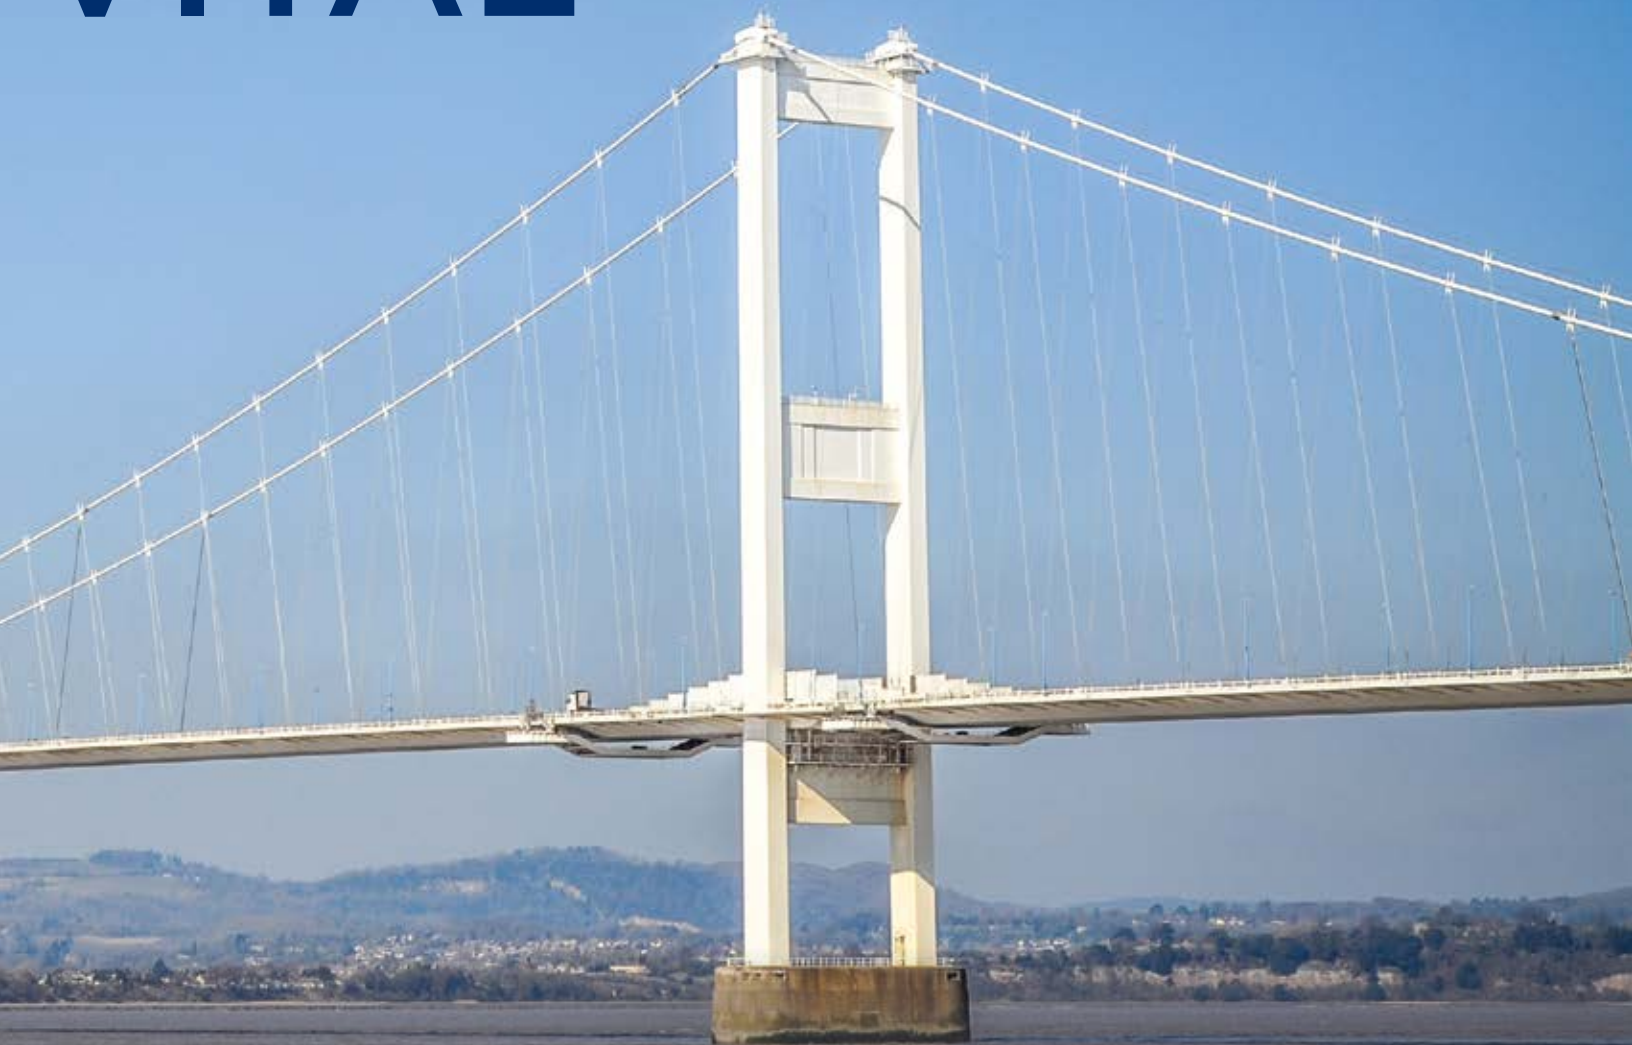
Cable-supported bridges are located all over the world. Most are found spanning bodies of water, making corrosion of the cables over time due to the earth's natural elements probable. To maintain their projected lifespan, inspections and upkeep is necessary. This complex craft is a unique challenge that allows American Bridge to continually develop specialized skills.

Next came the main event—the complete inspection of the eight main cable panels. An external inspection of the wrapping system of the cables was the first step. The inspectors examined the wrapping system by checking the cable for any visible abnormalities on the exterior, looking primarily for compromises in the protection of the wrapping. Inspectors were on the lookout for rust stains, beads of water, peeling paint, and cracks—all indications of a compromised wrapping system with potential water infiltration. Inspectors paid close attention at the midpoint of the mid span (the low point of the cable) due to its proximity to the roadway “splash zone” and the tendency of water to gravitate there.

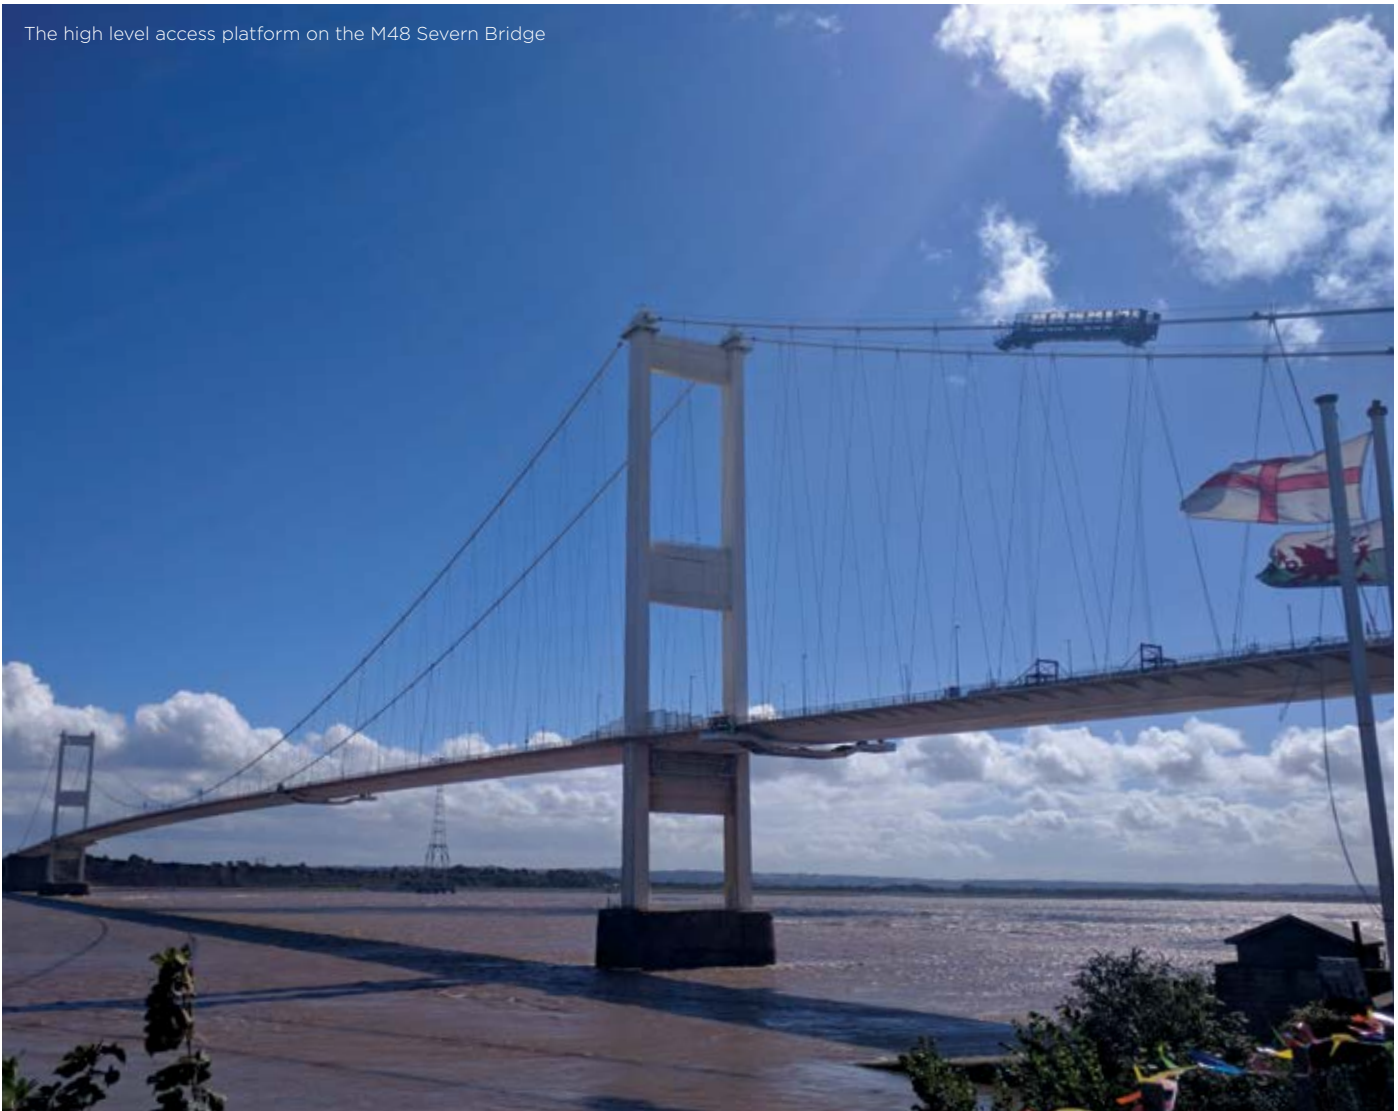
The high level access platform on the M48 Severn Bridge

Prior to the inspection, two access platforms—a Low Level (LLP) and a High Level (HLP)—needed to be designed and built. These platforms aided in the main cable inspection by allowing closer examination of the exterior of the cable. The HLP was used for the inspection of two high level main cable panels at different locations on the bridge. The LLP facilitated the inspection for the other six panels. As part of the contract, AB was responsible for the design, fabrication, installation, and operation of both.

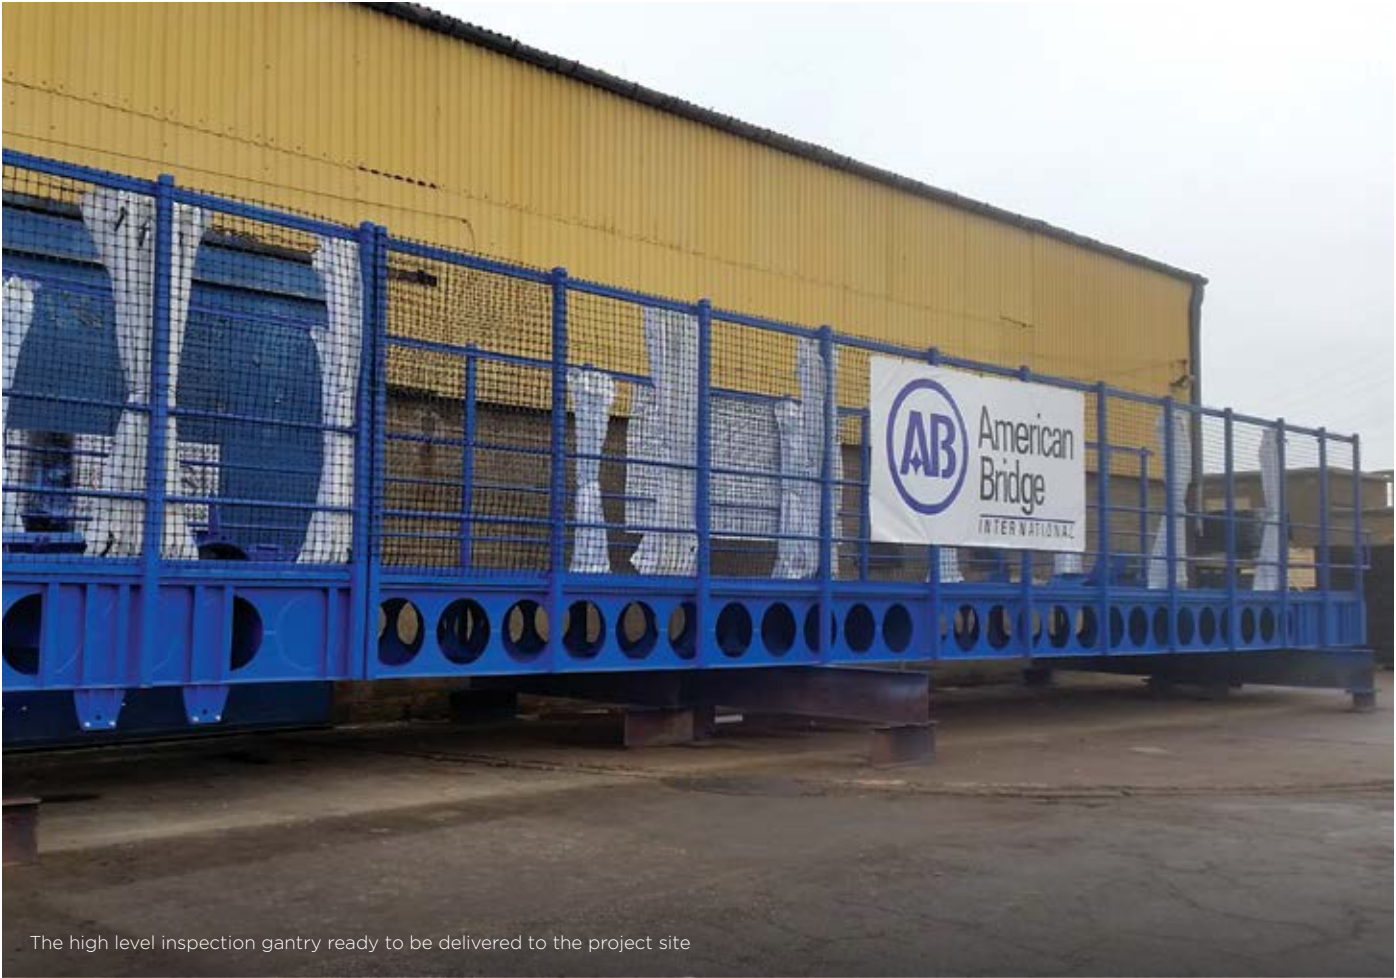
The high level inspection gantry ready to be delivered to the project site

Once the platforms were designed and fabricated, they were ready for installation. The HLP installation operation was an exercise in subconsultant and subcontractor coordination—all orchestrated by AB. To bring the operation under a single certifiable process, a custom Erection Scheme Certificate was

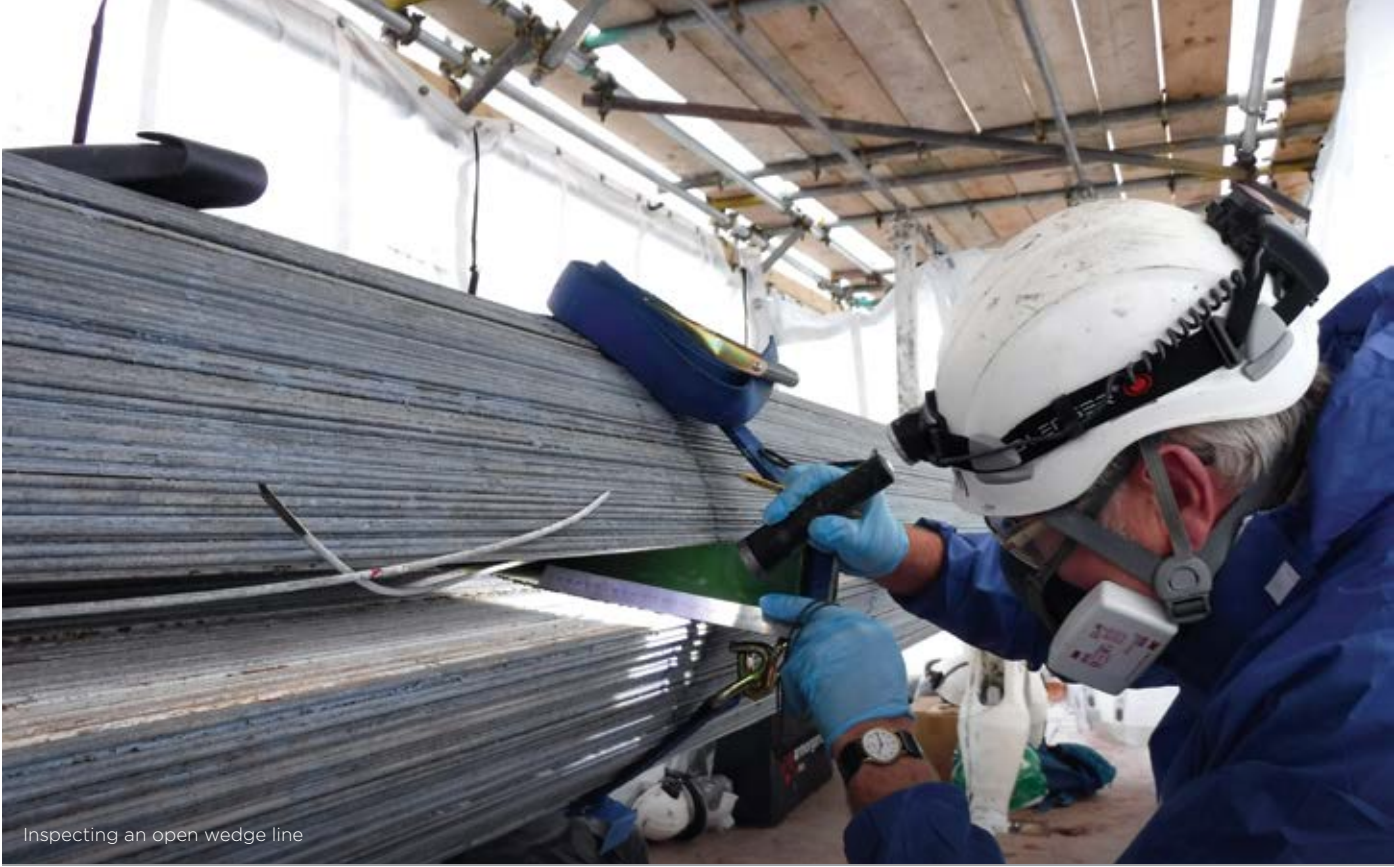
Inspecting an open wedge line

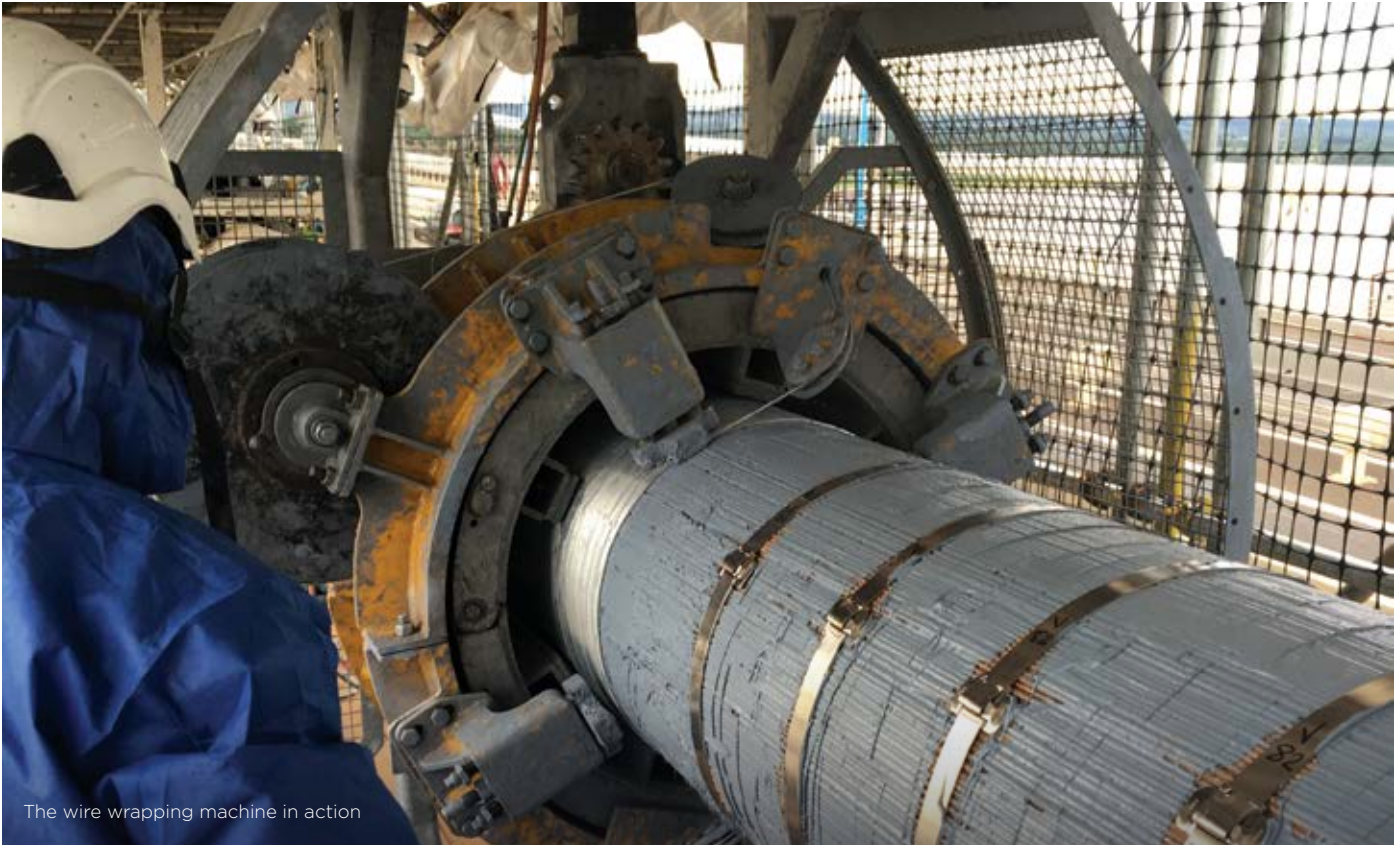
The wire wrapping machine in action

The cable was first compacted and held in shape with stainless steel strapping. Then the wrapper was installed and wire wrap was applied simultaneously with the zinc paste. Each stainless steel strip was removed as the wrapping wire advanced. A custom machine was used to apply circumferential wrapping wire to maintain the cable's circular shape. The wrapping machine was electrically powered and driven and controlled by a Siemens PLC system. It consisted of two main parts—the saddle sat on top of the cable and acted as the base for the machine, and the flyer which housed the wrapping wire spools and rotated around the saddle. The machine was capable of winding the wires with a minimum tension of 300 pounds around the cable. The wrapping wire tension was maintained by torquing the spool nuts, creating friction between the underside of the spool

and a brake pad is attached to the surface of the flyer.

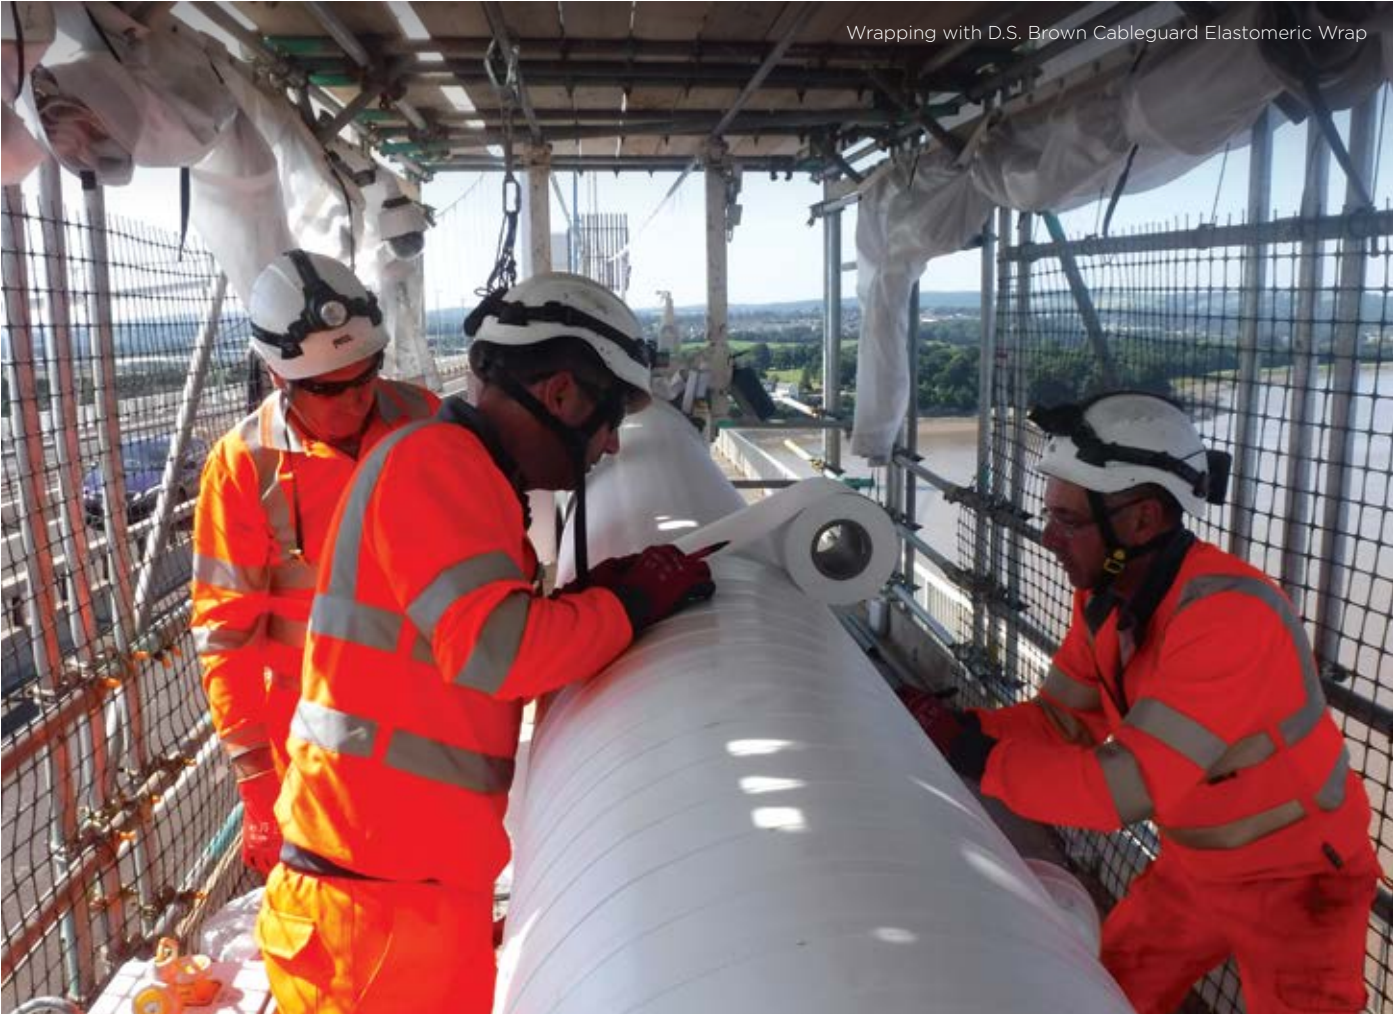
To improve safety and prevent manual handling, the team used a truck-mounted crane to load the wrapper and compactor at the yard and unload onto either the scaffold landing platform or the gantry cradle used to transport them to the high level gantry.

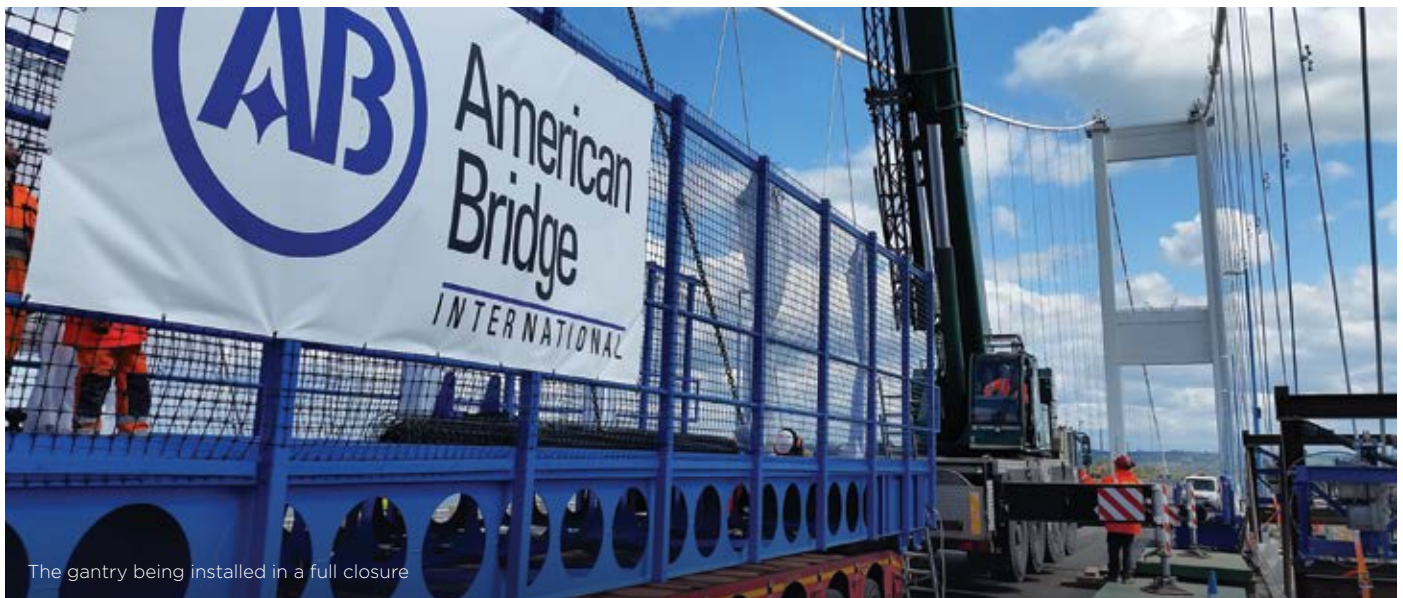
The gantry being installed in a full closure

developed in conjunction with AECOM. AB led the operation, supported by the designer, a crane supplier to lift the gantry to the trestles, and a specialist lifting company to hoist the gantry and secure it to the main cable. The certificate clearly defined all roles and responsibilities so they were understood and accepted by each party. The certificate was also used to confirm that the individual Risk Assessment Method Statements (RAMS) produced by each party were completed, checked, signed off and, most importantly, covered the relevant sections of work without leaving gaps in methods.

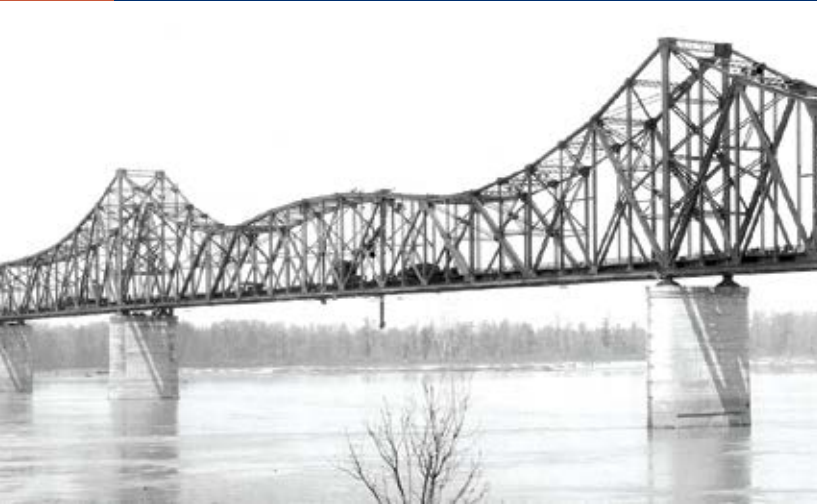
VICKSBURG BRIDGE

87 years ago, AB completed the construction of the Vicksburg Bridge, an 8,546' cantilever truss bridge, in just over one year. AB was the general contractor for this combined highway and railway bridge that spans the Mississippi River connecting Vicksburg, Mississippi and Delta Point, Louisiana. The bridge is now closed to vehicular and pedestrian traffic, but it is still in use by Kansas City Southern Railway.

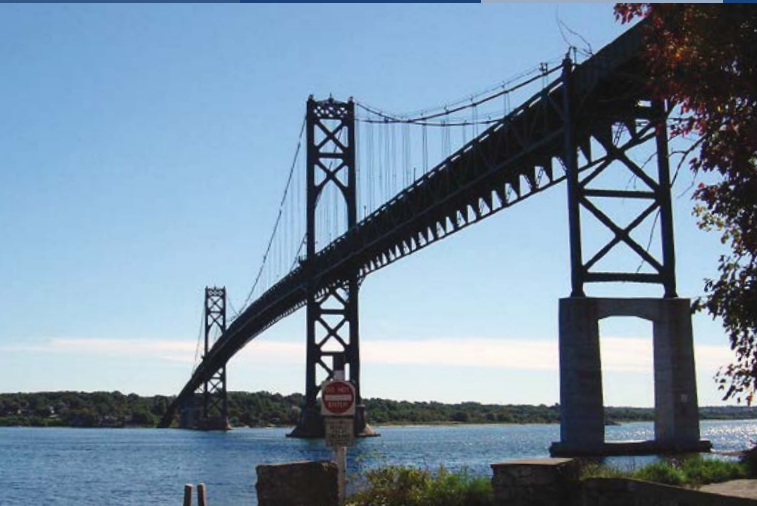
MT. HOPE SUSPENDER REPLACEMENT

AB completed the suspender replacement on the Mt. Hope Bridge, a crossing of Mt. Hope Bay in Bristol, Rhode Island, 14 years ago. AB was responsible for the removal and replacement of 109 pairs (218 total ropes) of 1 $\frac{3}{8}$ " diameter wire rope suspenders which varied from 11' to 253' in length. Work also included lead paint removal and new painting at the socket areas and cable bands and area painted prior to installing the new suspenders.

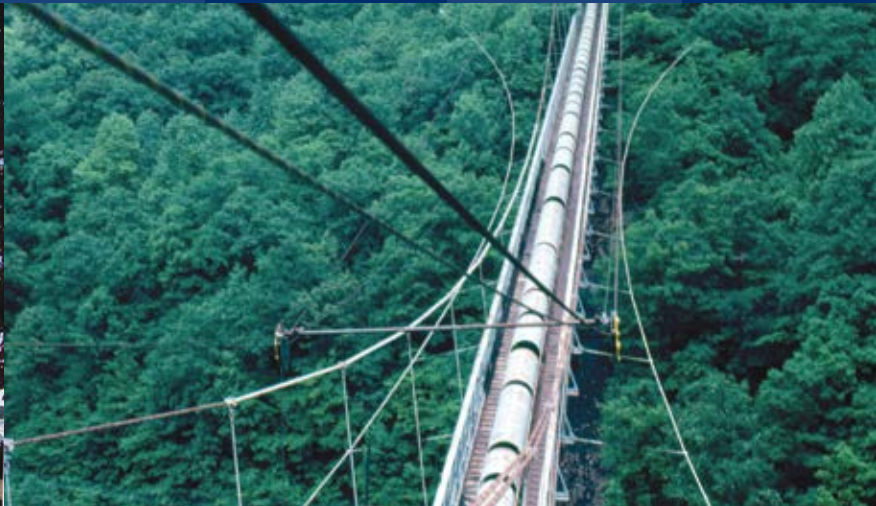
GARY REFUSE CONVEYOR BRIDGE

AB completed a main cable and suspender rope replacement on the Gary Refuse Conveyor Bridge 35 years ago. This 4-span 1,117' suspension bridge carries a mine refuse conveyor for the U.S. Steel Mining Company. Not only did AB complete the replacement, but all the design work for the project was also performed in-house by AB's engineering department.

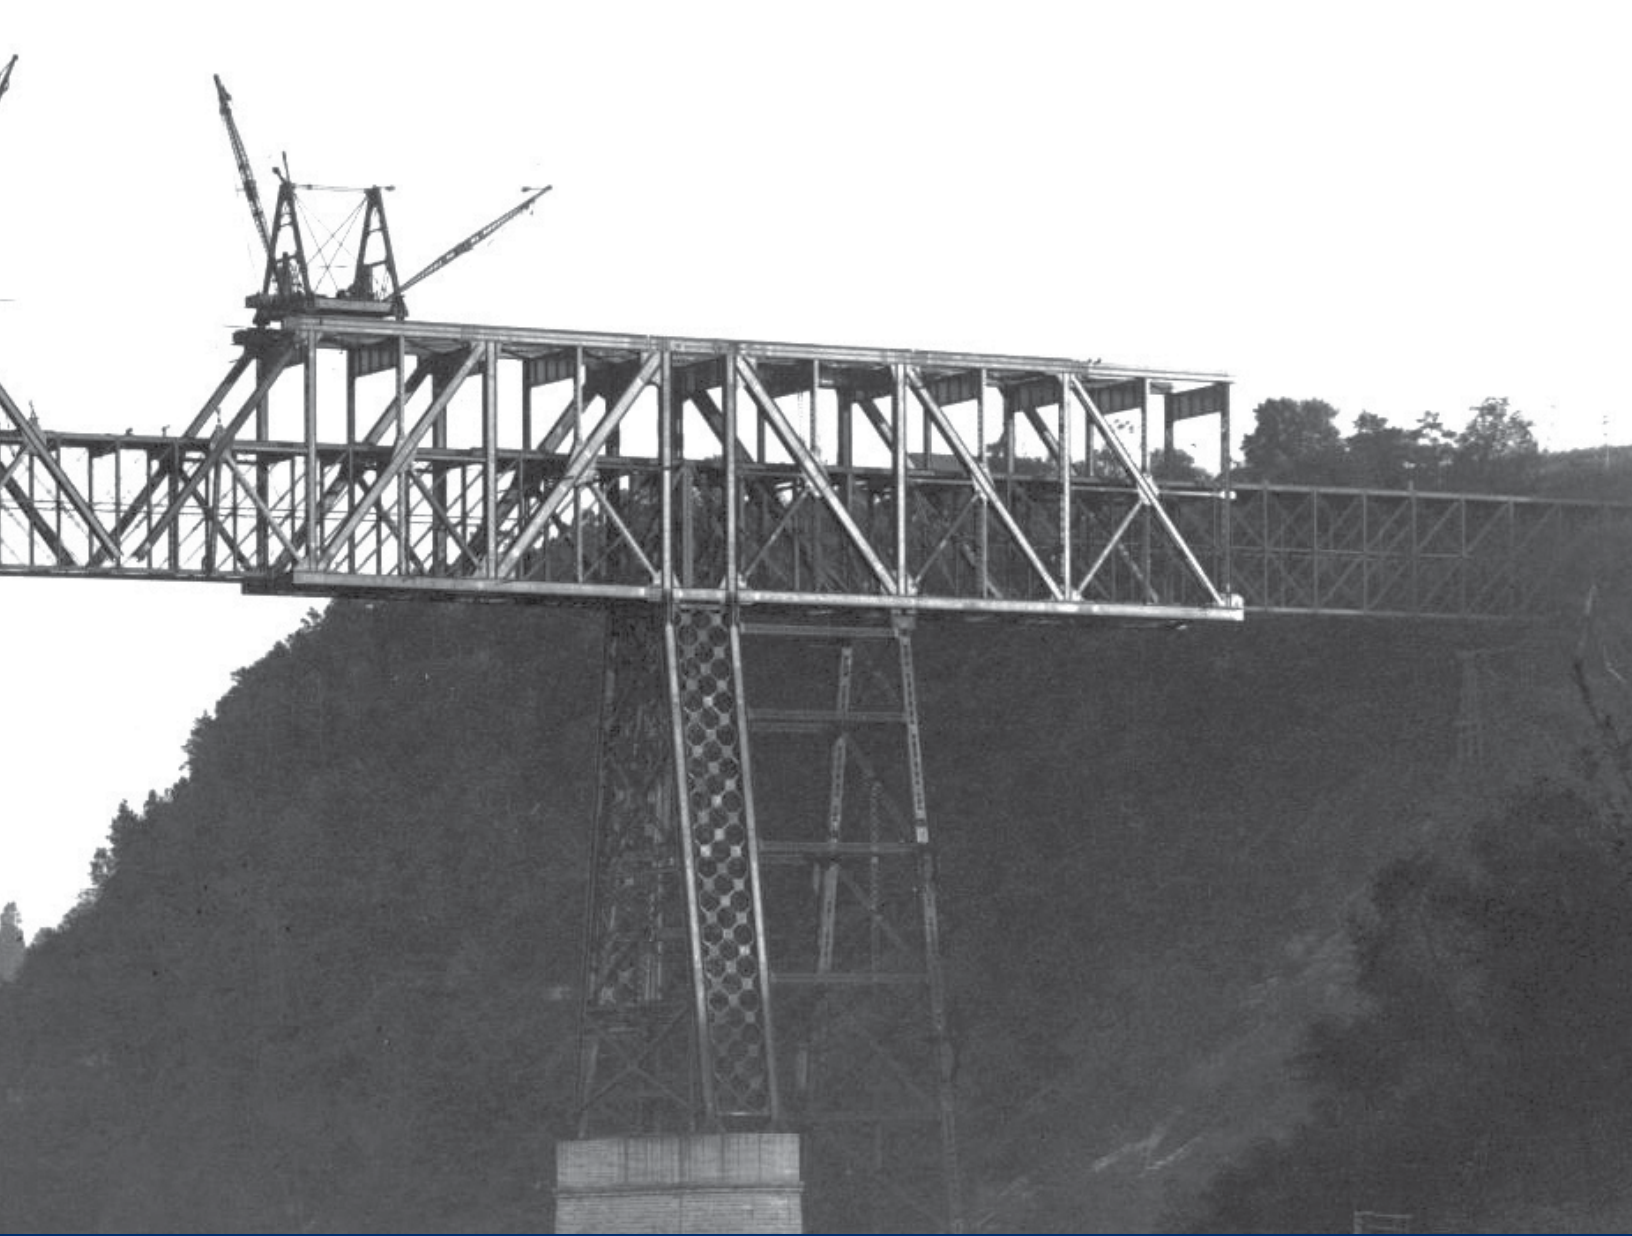
NORFOLK SOUTHERN KENTUCKY RIVER HIGH BRIDGE

truss, three by 353' on 160' towers. But because of the bridge's importance, the construction posed an interesting question. How would it be possible to keep this bridge in service while building a replacement in the same exact location? Closing the bridge was not an option. So, in order to make this possible, the new bridge was built completely surrounding the active iron structure—creating what was essentially a bridge within a bridge. A little less than three years

Both bridges coexisted for 18 years, but in 1929 the old bridge was removed and a second set of tracks was added to the AB-built structure. 56 years later, in 1985, the bridge was deemed a National Historic Civil Engineering Landmark by the American Society of Civil Engineers, who noted the project as one that “illustrates the creativity and innovative spirit of civil engineers” as well as an “achievement of what was considered an impossible dream”.

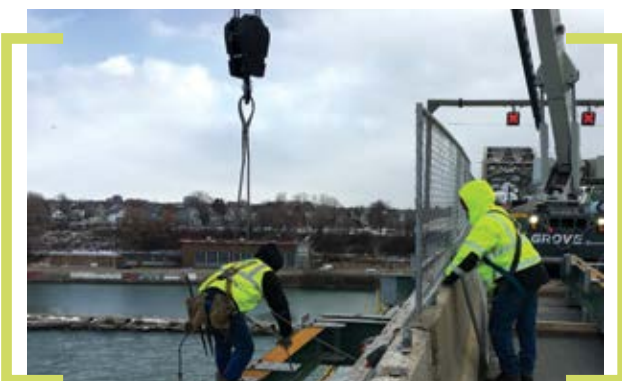
Fascia Stringer Erection CAS

Ironworkers from Local 6 Buffalo erecting steel over the Niagara River at the Peace Bridge project using appropriate fall protection and PPE, with a dedicated signal person for the crane; Photo Credit: Cory Sutherland, Field Engineer

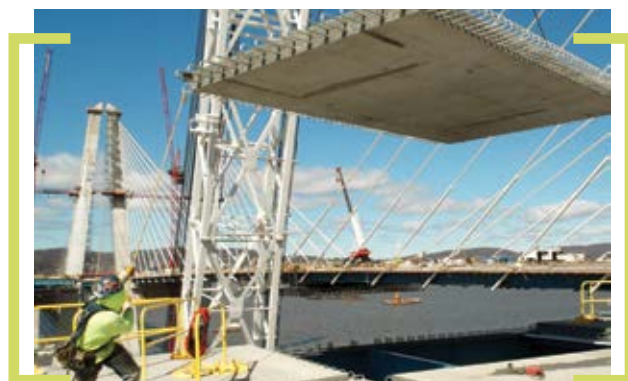
Ironworker setting a precast deck panel on the Tappan Zee Bridge using a tag line to control the load as well as utilizing a Garlock safety guardrail at the leading edge; Photo Credit: Andre Markarian, Engineer - Main Span
